# Technical Report – R20309 Rev 1 CWCT – Standard for systemised building envelopes – 2005

**Domus Facades Ltd**  
**DFS05 Support System - Rainscreen System Test**

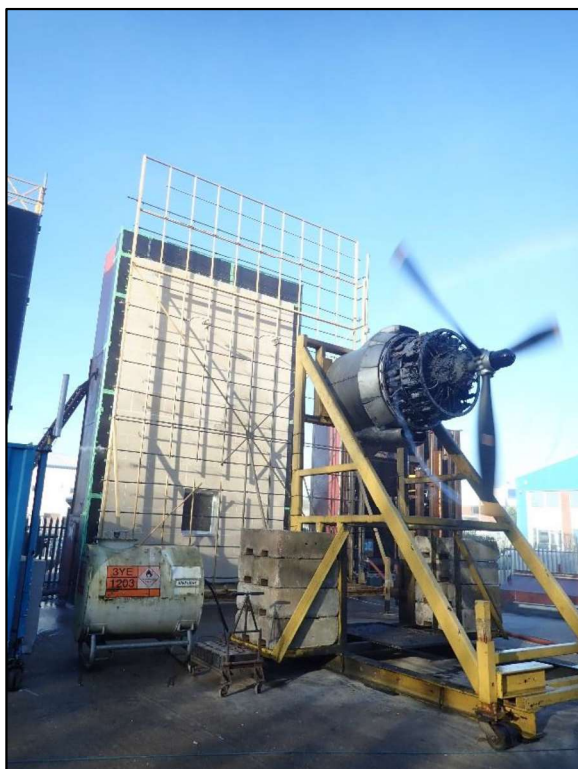
Photograph No. 1

**Sample during testing**

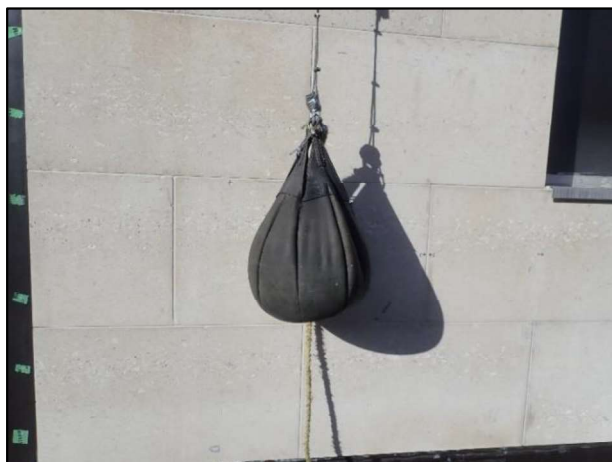
Photograph No. 3

Showing Soft Body (S1) impact of 120Nm.

During the above test, no damage was observed.

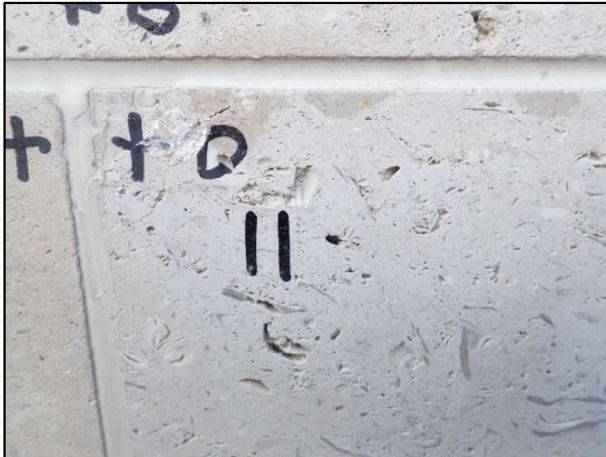
Photograph No. 9

The above damage resulted in a Class 2 being achieved during the Retention of performance test.
